Montgomery County Fire and Rescue Service

POST INCIDENT ANALYSIS

Major Medical & Technical Rescue Incident Montgomery Mall

Incident Date: May 23rd 2013

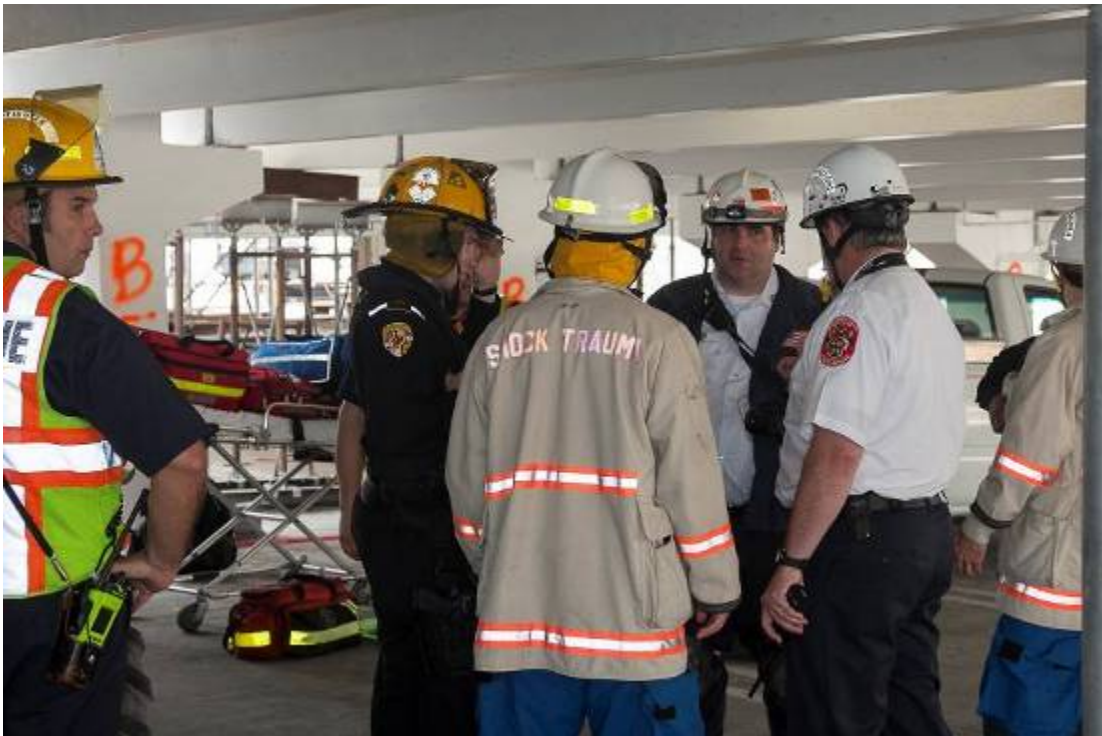
Figure 8 TRT Members assess and shore the interior area of the collapse
